P.O. Box 150974 Cape Coral, FL 33915 (239) 995-3622

BUILDING ANALYSIS REPORT

Property Location
<u>123568 W 9th</u>
<u>Cape Coral</u>
<u>FL</u>

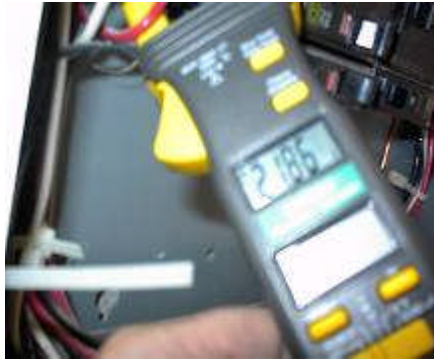
Photo # 5 Clothes dryer

* *Clothes Dryer was drawing 21.8 AMPS, normal. See Photo 5 (FYI)*

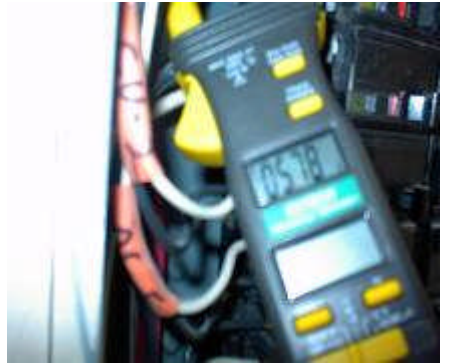
Photo # 6 AC condensor # 1

** AC compressor was drawing 5.78 AMPS, normal. See Photo 6 (FYI)*
 Cooling system appears to be in working condition

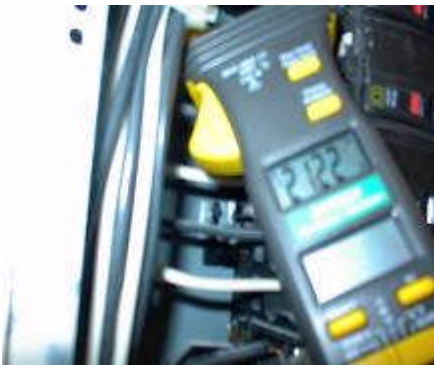
Photo # 7 AHU heat # 1

** Heating system was drawing 21.2 AMPS, normal. See Photo 7 (FYI)*
 Heating system appears to be in working condition

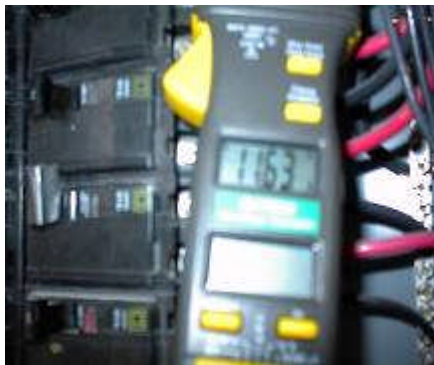
Photo # 8 AC condensor # 4

* *AC compressor was drawing 11.6 AMPS, normal. See Photo 8 (FYI)*

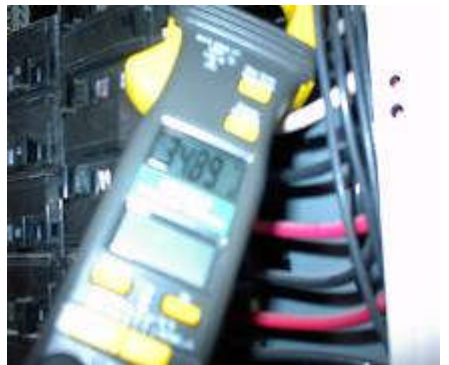
Photo # 9 AHU heat # 4

* *Heating system was drawing 34.8 AMPS, normal. See Photo 9 (FYI)*

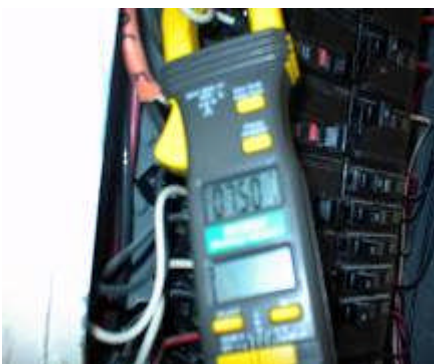
Photo # 10 AC condensor # 2

* *A/C unit #3, is not cooling up to normal industry standards at time of inspection. Unit had only a 2 degree drop in temperature. Unit should have at least a 15 degree drop across the cooling coils. See Photo 3 (supply air temp) Customer should have fully inspected by a licensed A/C contractor.*

* *AC compressor was drawing 7.5 AMPS. See Photo 10 (FYI)*

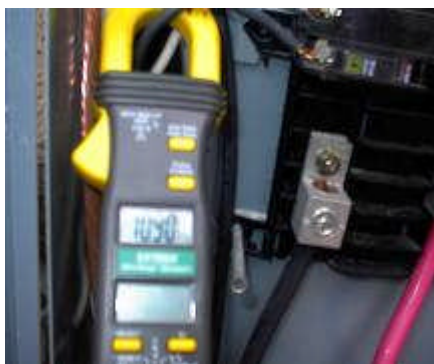
Photo # 11 AC condensor # 6

** AC compressor was drawing 10.9 AMPS, normal. See Photo 11 (FYI)*
 Cooling system appears to be in working condition

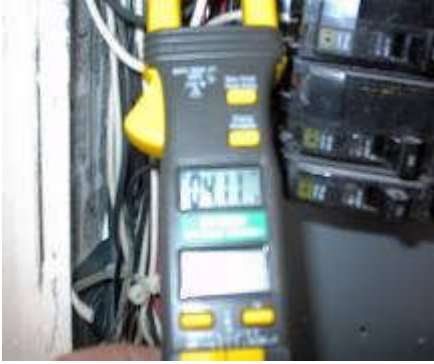
Photo # 13 AC condensor # 5

** Unit # 5 is 2nd floor West*
** Unit should have at least a 15 degree drop in temperature across the cooling coils. Temperatures were taken at several locations & 11 degrees was the best temperature drop found. Appears that this unit may be in need of service. Customer should have unit fully inspected by a licensed A/C contractor. See Photo 22 return temp and photo 23 Supply temp.*
** AC compressor was drawing 4.1 AMPS. See Photo 13 (FYI)*
 Cooling system appears to be in working condition

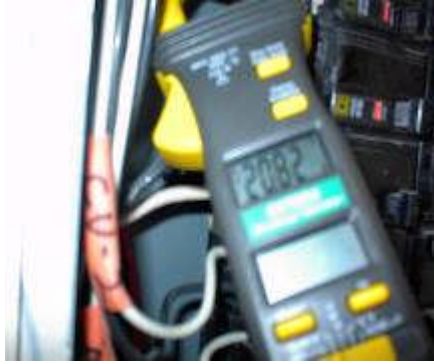
Photo # 14 AHU heat # 3

* *Heating system was drawing 20.8 AMPS, normal. See Photo 14 (FYI)*

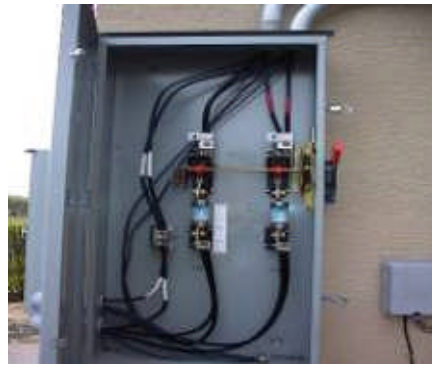
Photo # 35 Main Disconnect

* *Power was disconnected at main disconnect switch (see Photo 35) and generator started, fired & transferred in approx. 30 seconds restoring full power to house. (FYI) See Photos 37-39 of Generator (FYI)*

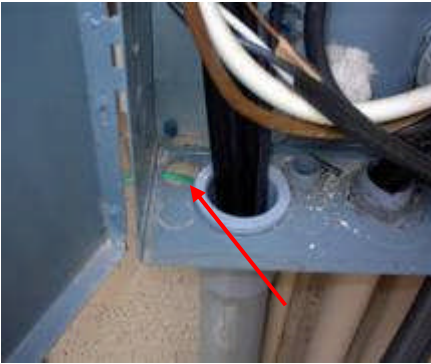
Photo # 40 Electrical Pnl @ meter

- * *Open junction box noted in the storage area above the Master bedroom closet, South end. Minor See Photo 46*
- * *Knock out seal missing in the bottom of the main breaker panel 2' West of electrical meter. Open knock out seal is allowing wasps to make nest inside electrical panel. See Photo 40*
- * *The fountain pump East of the front entry door is not operational.*

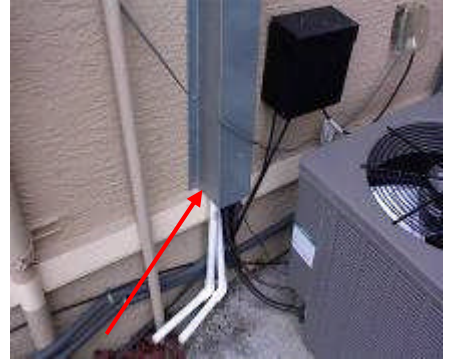
Photo # 42

** Unit is labeled as a 10kw air handler, however appears that only a small part of the heat strips are engaging & operating at time of inspection. Unit during heating operation was only drawing 15.2 amps (See Photo 6) & should draw approx. 42amps during normal 10kw heat operation. Appears that not all the heat strips are engaged or may not be connected in air handler due to unit being operated in garage.*
** The A/C compressor gas line chase next to the electrical meter is not properly foam filled & sealed to prevent rodents from entering into the attic. See Photo 42*
 Heating system appears to be in working condition

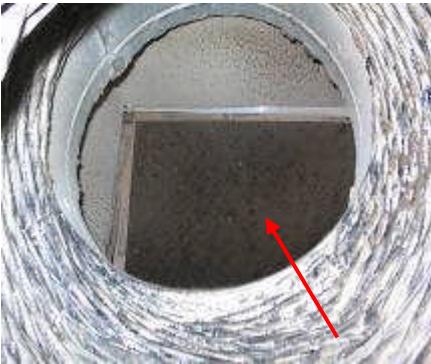
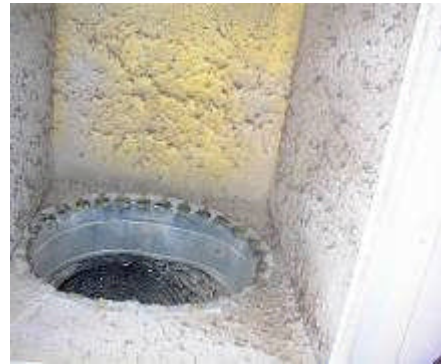
Photo # 43 Return air # 1

** A/C filter, unit #1 for Master bedroom, is disposable & completely blocked with dirt & dirt build up noted in air return in Master closet. (filter changed during inspection) See Photo 43 & 44*

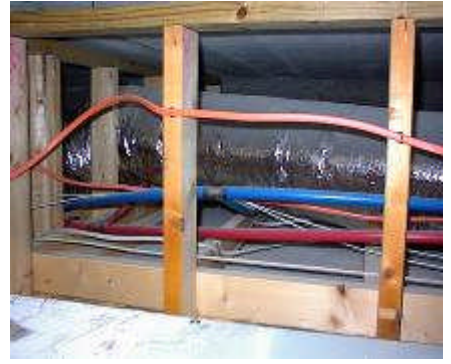
Photo # 45 Plumbing Water lines

Interior Pipes & Additional Fixtures Type of pipes: Plastic Satisfactory
 ** The kitchen sink has lost its seal & bond to the underside of the granite countertop. See Photo 62* See Notes *
 ** House is piped in red & blue polybutylene type plastic. See Photo 45 (FYI)*

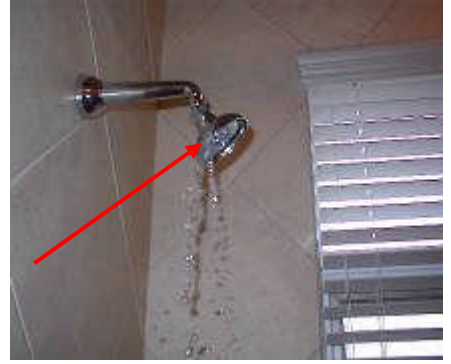
Photo # 48 2nd fl SW bath

** No hot water flow noted thru shower head & cold water flow is weak during operation. See Photo 48*

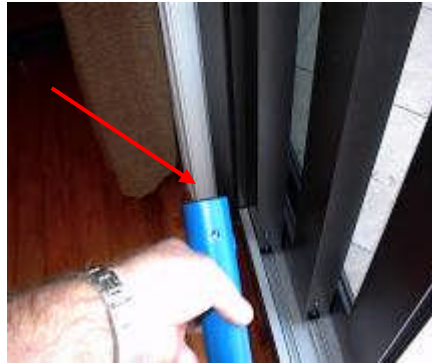
Photo # 50 2nd fl game rm SGD

- * *Stains noted, moisture detected with a moisture meter in the wood flooring at the E. end of the 2nd floor game wood sliding glass doors. Appears that moisture is penetrating these doors at time of inspection. Some signs of deteriorated flooring in other areas along the threshold, however no moisture detected in these areas. See Photo 50*

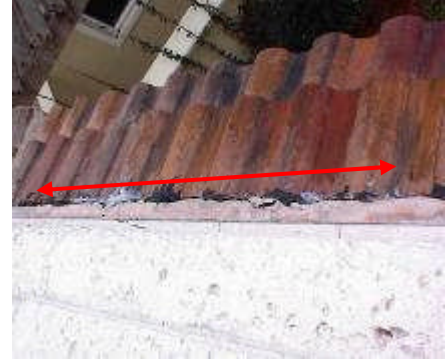
Photo # 51 1st fl roof line SE

** Signs of roofing repairs noted; taring & siliconing at the top of the 1st floor overhang below the 2nd floor balcony area along the entire East side and SE corner. unknown reason for repair work no signs of leking visible. See Photo 51*

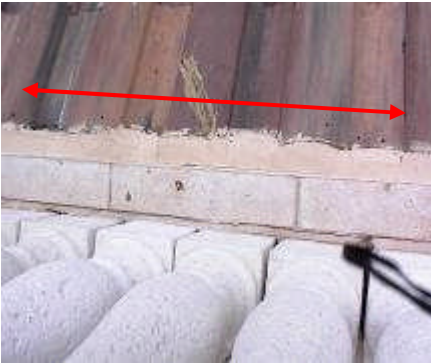
Photo # 52 1st fl roof line SW

** Some visible screws noted run thru some of the roof tiles on the 2nd floor overhang, visible from 2nd floor West balcony area. See Photo 52 Not all these tile areas have screws thru them, only the section facing South, unknown why.*

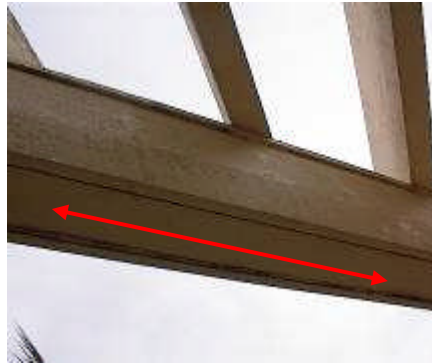
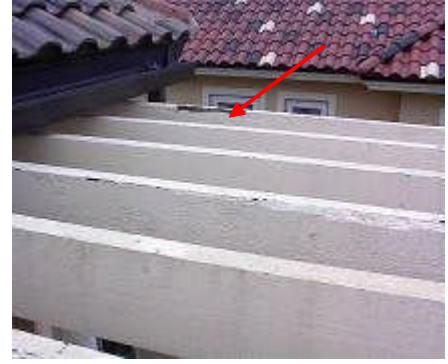
** Some minor wood trim deterioration along the 2nd floor SE balcony outside the game room on the wood beam near the SE corner & at the NE corner of the wood trim 2nd floor balcony. See Photo 53 & 54*

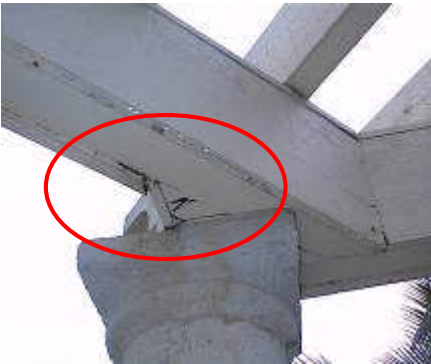
Photo # 55 Wood beams 2nd fl west

** Wood trim deterioration noted at the SW corner of the SW 2nd floor balcony area. See Photo 55*

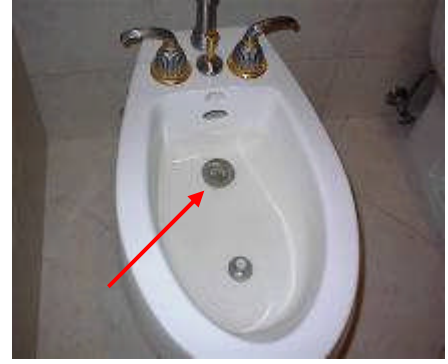
Photo # 57 Master bath bidet

** Appears that the bidet stopper system is frozen. See Photo 57*

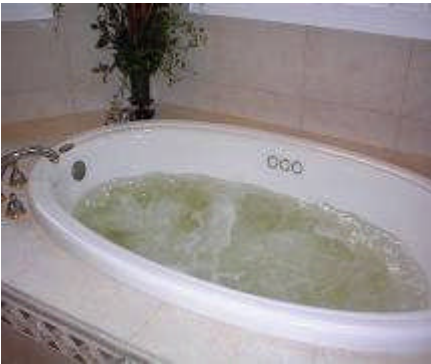
Photo # 58 Master bath spa tub

** Spa filled & operated properly at time of inspection. (FYI) See Photo 58*

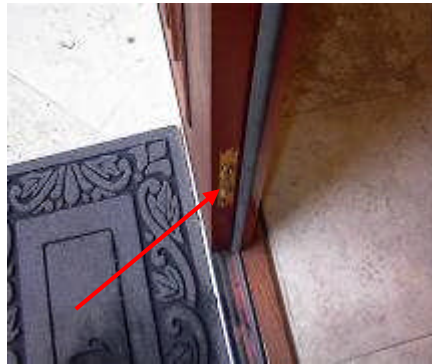
Photo # 59 Front entry door

- * *The bottom latch pin on the fixed panel front entry door is not unlatching properly to allow the door to open. See Photo 59*
- * *Stains noted, no moisture detected with a moisture meter at the wood base molding inside the two double french doors South side of the living room bay window area., stains appear to be from past leaking.*

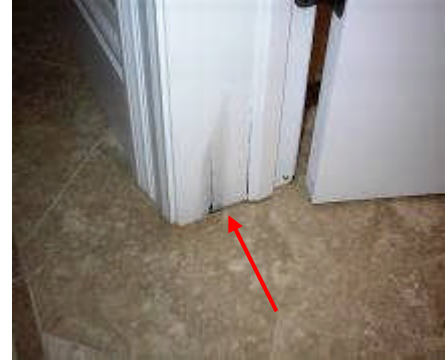
Photo # 60 Pool bath hall door

Doors All interior doors operate normally Satisfactory
** Stains noted, no moisture detected & some minor wood deterioration noted on the door casing on the hinge side of the pool bath door jamb, appears that possible moisture may have leaked out of shower stall during use and seeped over to this door jamb to cause deterioration due to no moisture detected at this time. See Photo 60* See Notes *
