P.O. Box 150974 Cape Coral, FL 33915 (239) 995-3622
New Construction Final Inspection

Property Location
1234 SW 5th
Cape Coral
FL

Inspector	Community	Address	Builder	Lot	Facing
Steve Johnson	Cape Coral	921 SW 5 <sup>th</sup> Terrace	Barony Homes		<u>North</u>
Date	Time	Customer	Inspection Number		
10-01-07	PM	Carol Sansevero	0710021		
The purpose of this inspection is to identify any damaged, incomplete, missing, items not working properly or other problems visible in the home at the time of the inspection.

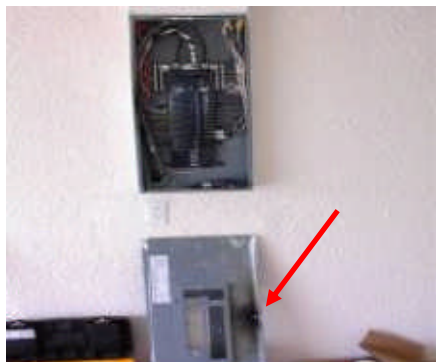
Photo # 2

Line	Trade	Description	See Photo	Corrected
1	29	The concrete step at the garage overhead door is not level & garage overhead door does	8	.
2		not seal at the W. end when closed. See Photo		.
3				.
4	12	It appears that the center left panel cover screw was driven into the B phase leg of the	2	.
5		electrical panel & shorted it. Inside of electrical box is black & charred indicating short	6	.
6		circuit on Main feeder leg. Appears that the electrical feeder wire was simply taped over	7	.
7		at the damaged area. Wire should be removed & replaced & panel box properly cleaned to		.
8		remove black charring showing short circuit. See Photos		.
9				.
10	45	Shutter panels need to be stacked & properly secured in the corner of the garage. A large		.
11		stack of shutters noted on garage floor at this time.		.
12				.
13	01	The door casing is banged up, dented & scratched at several locations on the door to the		.

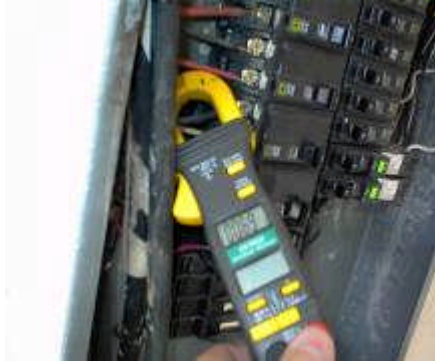
Photo # 3

102				.
103	11	Hot water heater is not operational at time of inspection. Water heater had no amperage	3	.
104		draw. See Photo No hot water available at any fixtures thru out the house.		.
105		Unable to verify proper hot water operation in house.		.
106				.
107	45	The shutter bolts that did not have rubber end caps installed have paint over top of them		.
108		& paint does not allow wing nuts to properly tighten down on shutters.		.
109				.
110	45	Unable to locate remaining shutter hardware, wing nuts, map for shutter locations & any		.
111		other information regarding shutter system.		.
112				.
113	12	Circuit 3 & 5 has 8 gauge wire on a 60 amp breaker for the air handler heat. Heating	27	.
114		system draws approx. 40 amps during full 10kw heat operation. Wire is adequate for		.
115		load size, however wire is undersized for breaker size at 60 amps. Breaker 7 & 9 for A/C		.
116		condenser has 6 gauge wire on a 40 amp breaker. Unknown why smaller 8 gauge wire		.

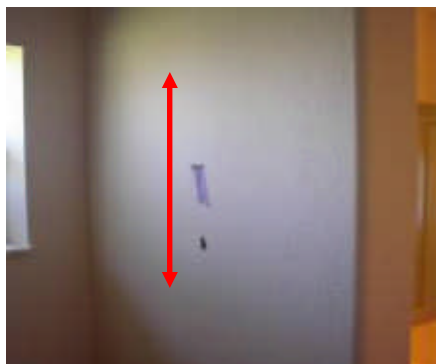
Photo # 11

Line	Trade	Description	See Photo	Corrected
29	08	The drywall texture finish is uneven, too smooth, appears to have been patched on the wall	11	.
30		E. of the toilet in the Guest bath. See Photo Drywall finish is uneven also below	12	.
31		mirror, medicine cabinet & below light fixture in Guest bath.		.
32				.
33	13	The back of the vanity cabinet in the Guest bath is cut way too large at the water supply	13	.
34		lines & the drain supply line, creating a large hole, looks poor. See Photo		.
35				.
36	11	Scratches & marks noted on the outside finish of the tub area. See Photo	14	.
37				.
38	25	The ceramic grout was not properly cleaned off the floor where it meets the vanity cabinet	15	.
39		in the Guest bath. See Photo		.
40				.
41	02	The threshold at the exterior door to the rear patio from the Guest bath is not properly		.
42		secured down. Threshold floats up & down when stepped on.		.
43				.
44	02	The receiver hole for the deadbolt on the door to the Guest bath from the patio is not	16	.

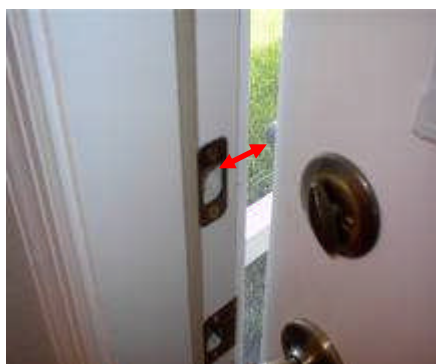
Photo # 16

45		drilled deep enough to allow the deadbolt to throw all the way into the jamb. Deadbolt can		.
46		be easily opened with a knife from the outside. See Photo		.
47				.
48	14	The countertop right of the stove is not properly secured to the base cabinet. See Photo	17	.
49				.
50	12	No switch installed for future pool light at W. end of living room sliding glass doors, as	18	.
51		shown on drawing.		.
52				.
53	08	The drywall texture is uneven & does not match the knock down finish between the two	19	.
54		switches W. wall of the living room.		.
55				.
56	08	The ground corner bead is popped loose & cracking at the S. end of the W. wall of the		.
57		living room.		.
58				.
59	03	Stains noted, extensive moisture detected in the baseboard trim & drywall at the window	20	.
60		sill area & below the window sill area on the center & W. windows of the dining room.	21	.
61		Significant moisture detected with a moisture meter at this time indicating moisture	22	.

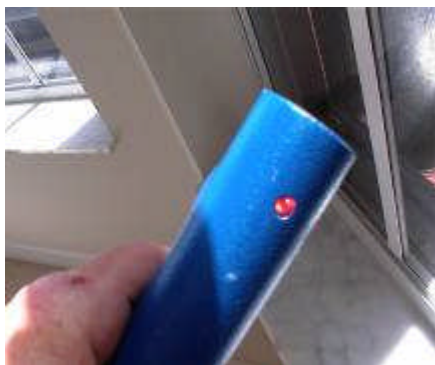
Photo # 21

62		penetrating thru exterior wall or window frame areas at this location. Drywall is soft &		.
63		deteriorated at the window sill area & baseboards have extensive moisture & staining is		.
64		beginning. See Photos		.
65				.
66	02	The following items were noted on the exterior front entry doors: 1) the bottom latch		.
67		pin is not drilled deep enough to allow the deadbolt to throw all the way into the		.
68		jamb & header & allow safety catches to turn & lock. 2) Some damage has occurred to		.
69		the safety catch in the fixed panel front entry door See Photo 3) the receiver plate	23	.
70		for the deadbolt is not properly positioned to allow the deadbolt to properly throw into the	24	.
71		jamb 4) damage noted on the edges of the front entry door, appears that someone has		.
72		attempted to unlock the doors from the outside by dropping the latch pins.		.
73				.
74	02	The rollers on the sliding glass doors in the living room & Master bedroom are extremely		.

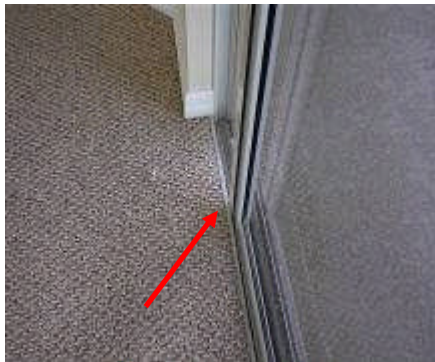
Photo # 25

75		noisy when being rolled back & forth, unknown why.		.
76				.
77	02	The inner sliding glass door at the Master bedroom drags on the inside of the track when	25	.
78		being opened. See Photo		.
79				.
80	23	Silicone needs to be applied between the mirror & the backsplash to prevent deterioration		.
81		of the mirror finish.		.
