FOUR POINT INSURANCE INSPECTION

Property Location
123456 5th St
Ft. Myers FL
Approximate Year Built : 1976

Inspection Number: 0711141 ins

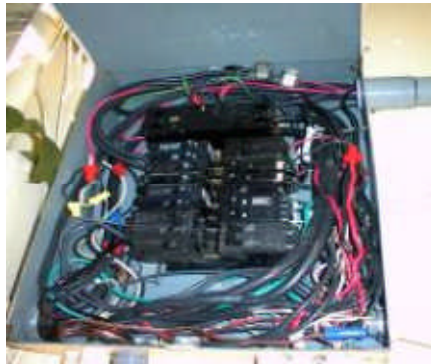
Photo # 5

** New electrical panels were installed in 2004.
 See Photos 5, 6, & 7*

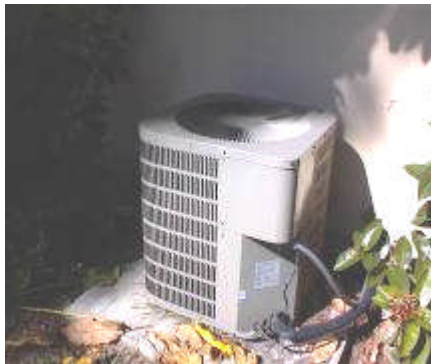
Photo # 8

** The AC Cooling system is 2 years old and was updated (installed in 2005). System is in very good condition and System should have 15+ years of remaining life expectancy. Unit is proper size for home 2000 Sq ft living area. See Photo 8*

Cooling system appears to be in working condition

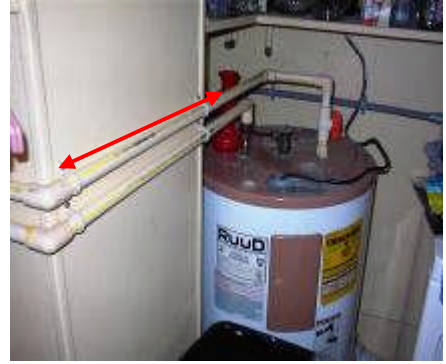
Photo # 9

Interior Pipes & Additional Fixtures Type of pipes: Plastic Satisfactory
** The Plumbing water lines are 2 years old and were updated (installed in 2005) to CPVC type plastic pipes. System is in good proper working condition and system should have 25+ years of remaining*
See Photos 9 & 10 *See Notes **

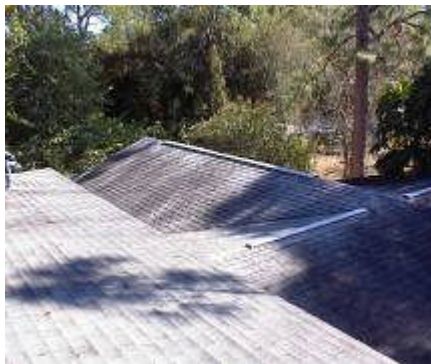
Photo # 11

** The main house Roof system is a 30 year dimensional shingle that was installed (updated) approximately 7 years ago in (2000). See Photo 12*
** The rear addition Roof system is a 30 year dimensional shingle that was installed (updated) approximately 5 years ago in (2002). See Photo 11*

Both Roof systems shows no signs of leaking and is in good condition. Roof system should have 10+ years of remaining life expectancy.
