# BUILDING ANALYSIS REPORT

**Property Location**  
8888 Home St. # 2  
Ft. Myers  
FL

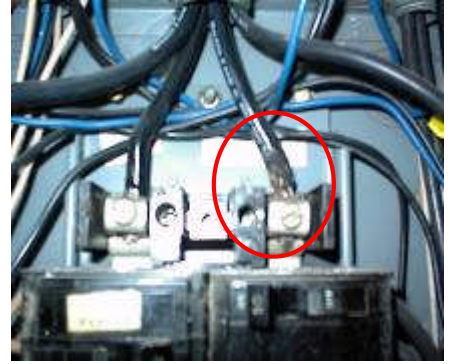
Photo # 3

**Electrical Service** Service entrance: Underground Type: SO-D  
 Main Panel Box 125 AMPS Voltage: 120 / 240  
 Circuit Breakers  Fuses  Grounded Properly  Satisfactory  
 See Notes \*  
*\* The B phase connection on the main lug at the top of the electrical panel appears to have a bad connection. Extensive heat build up noted on thermo scan, See Photo 4 (156.3 degrees) & some insulation heat damage noted on wire in panel. See Photo 3*

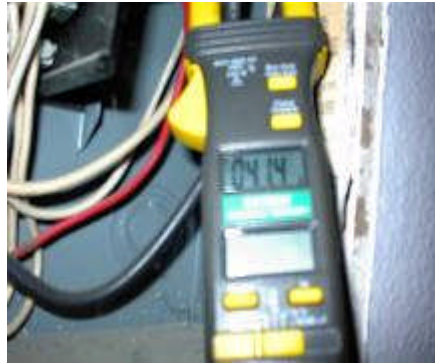
Photo # 5

*\* Heating system was drawing 41.4 AMPS, normal. See Photo 5 (FYI)*  
 Heating system appears to be in working condition

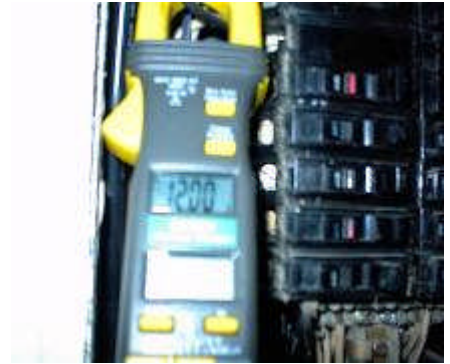
Photo # 6

*\* AC compressor was drawing 12.0 AMPS, normal. See Photo 6 (FYI)*  
 Cooling system appears to be in working condition

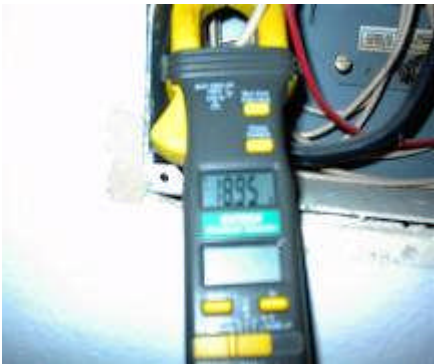
Photo # 7

**Hot Water Heater** Type of unit: Electric  Satisfactory  
 Capacity: 30 Gal. Ample for 2 - 3 people  See Notes \*  
 Age: 15+ years Approx. Temp. 123 \* *Unable to verify exact size & age of water heater. Water heater is located between kitchen sink & stove, under kitchen counter top. Unit is not accessible.*  
 \* *Hot Water Heater was drawing 18.9 AMPS, normal. See Photo 7 (FYI)*

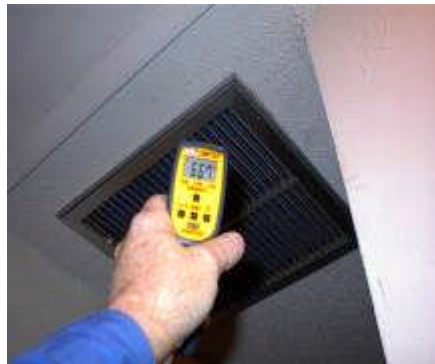
Photo # 8

**Unit**                      Age: 16 years                      Capacity: 2 1/2 Ton                       Satisfactory  
1                       Tested                       Not Tested                       N/A  
 Temperature: In 66.7                      Out 48.5                      = 18.2                      Degree Drop                       See Notes \*

*\* Unit is cooling properly at this time ( FYI)*

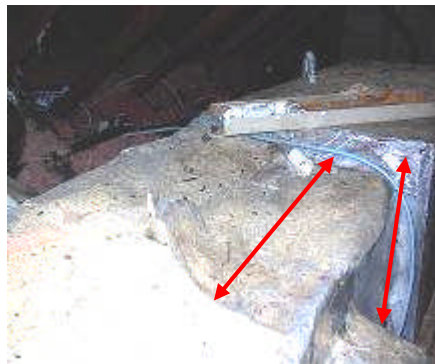
Photo # 11

**Air Distribution**       Ductwork air flow                       Radiators                       Satisfactory  
 Convertors                       Ducts not visible                       N/A  
*\* Air conditioning supply duct is not properly sealed where it connects to the air handler See Photo 11 & 12 and the supply duct is damaged along the top just past the air handler. See Photo 11*                       See Notes \*

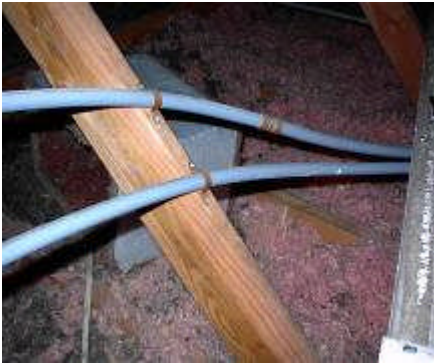
Photo # 13

**Interior Pipes & Additional Fixtures** Type of pipes: Plastic Copper Gray Poly Type Pipes  Satisfactory  
 See Notes \*  
 \* *House is piped in copper & gray polybutylene plastic type pipes. See Photo 13 (FYI)*

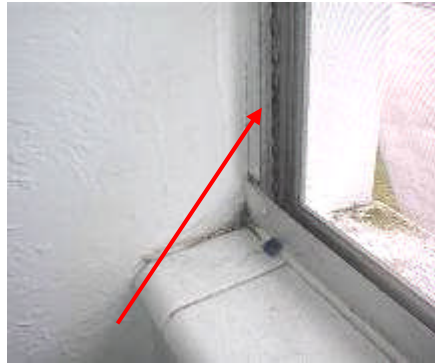
Photo # 14

*\* Window spring broken, S. side of the W. window at the Master bedroom See Photo 14*

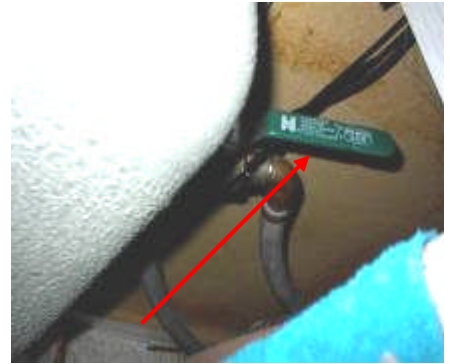
Photo # 15

\* *Main water shut-off valve is located under the kitchen cabinet, right of the kitchen sink. (FYI) See Photo 15*

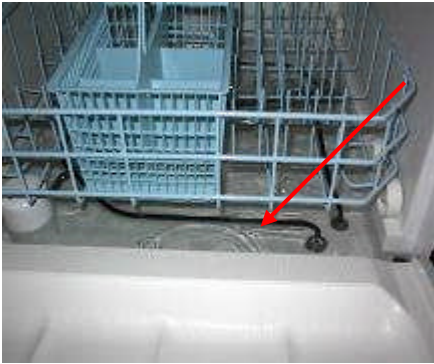
Photo # 16

**Dishwasher**  Operated  Not Operated Age: 15+- years  Satisfactory  
 N/A  
 See Notes \*  
*\* Dishwasher would not agitate properly or pump out. Unit would agitate for a short time & then stop. Unit filled & did not properly pump out at time of inspection. See Photo 16*
