P.O. Box 150974 Cape Coral, FL 33915 (239) 995-3622

BUILDING ANALYSIS REPORT

Property Location
<u>123568 W 9th</u>
<u>Cape Coral</u>
<u>FL</u>

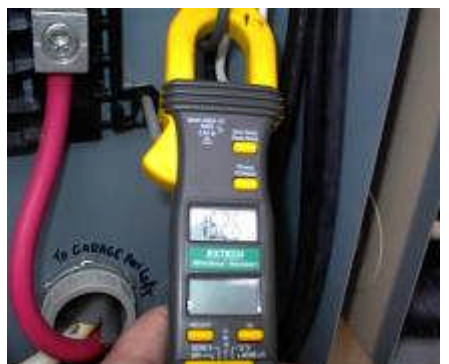
Photo # 10 AC condensor # 2

* *AC compressor was drawing 7.5 AMPS. See Photo 10 (FYI)*

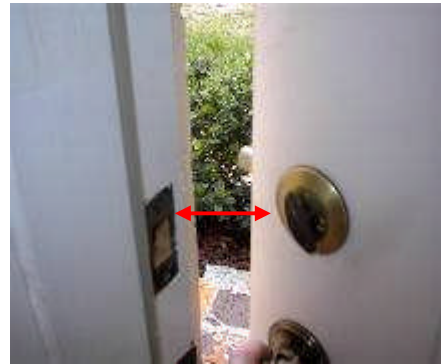
Photo # 47 Garage side door

- * *The receiver hole for the deadbolt on the garage side door is not drilled deep enough to allow the deadbolt to throw all the way into the jamb. Deadbolt can be easily opened with a knife from the outside. See Photo 47*

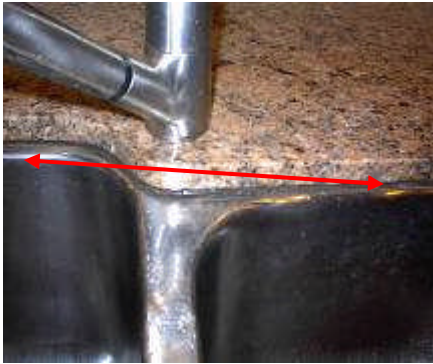
Photo # 62 Kitchen sink	Photo # 63	Photo #
-------------------------	------------	---------

Interior Pipes & Additional Fixtures Type of pipes: Plastic Satisfactory
 ** The kitchen sink has lost its seal & bond to the underside of the granite countertop. See Photo 62* See Notes *
 ** House is piped in red & blue polybutylene type plastic. See Photo 45 (FYI)*
